Section 19 Investigation Report

Date of Incident	28 th June 2021	Date of Report Version – 5.0 08/06/22 Status
Site / Catchment Location:	Chard, Coombe St Nicholas / Wadeford, Wambrook, Nimmer, Tatworth & Forton, Chaffcombe

This report covers the heavy rainfall incident on 28th June 2021, and the subsequent flooding in Chard and surrounding villages and hamlets.

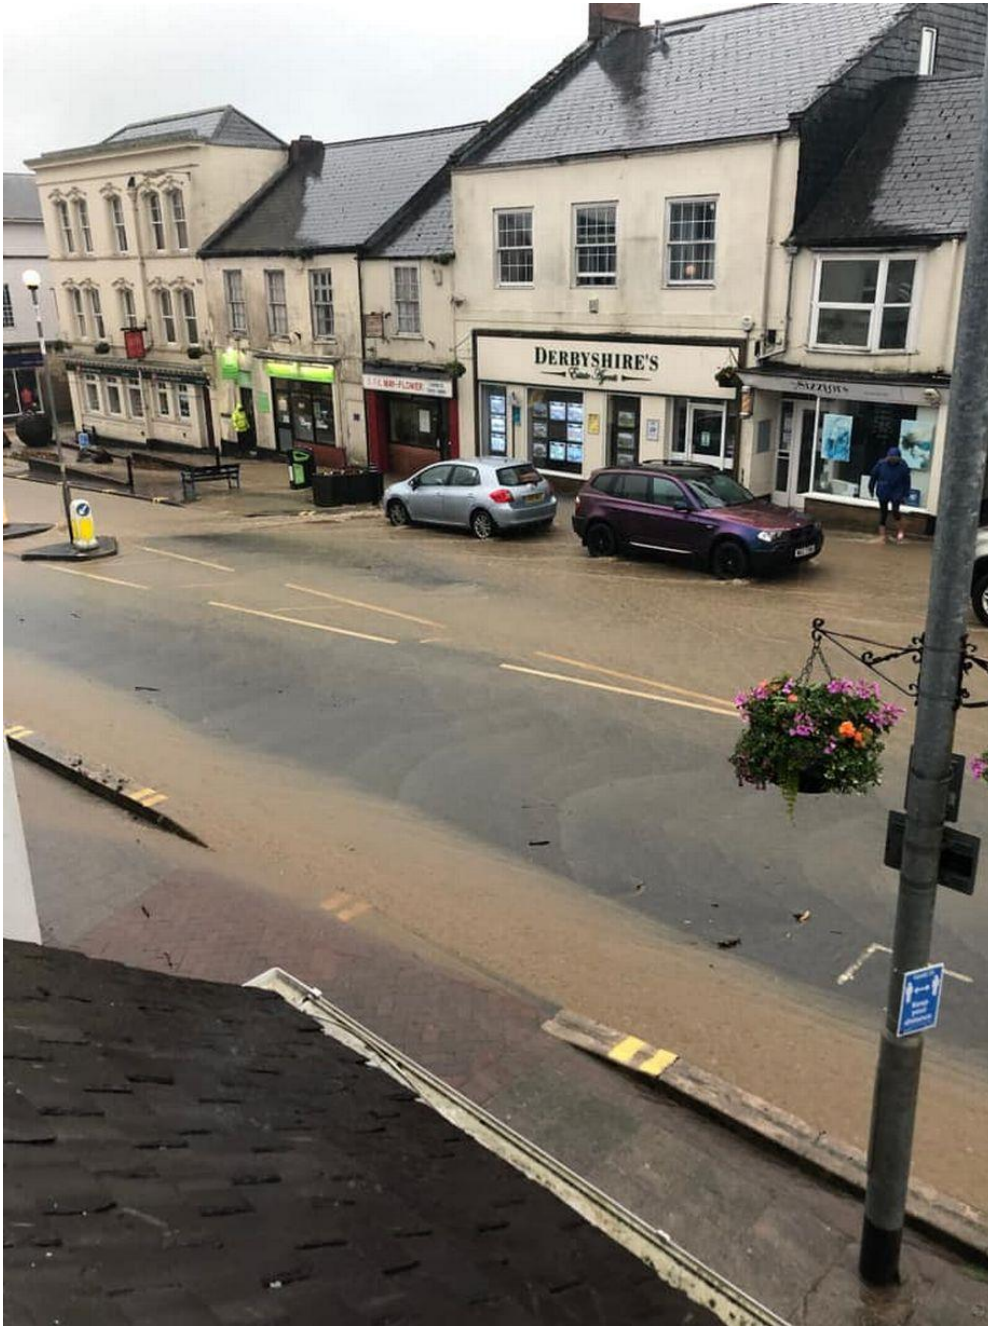
Figure 16: High Street, Chard

Flooding around the High Street was shallower, but fast flowing on the highways. There were reports of houses flooding in the High Street but which ones has not been firmly ascertained.

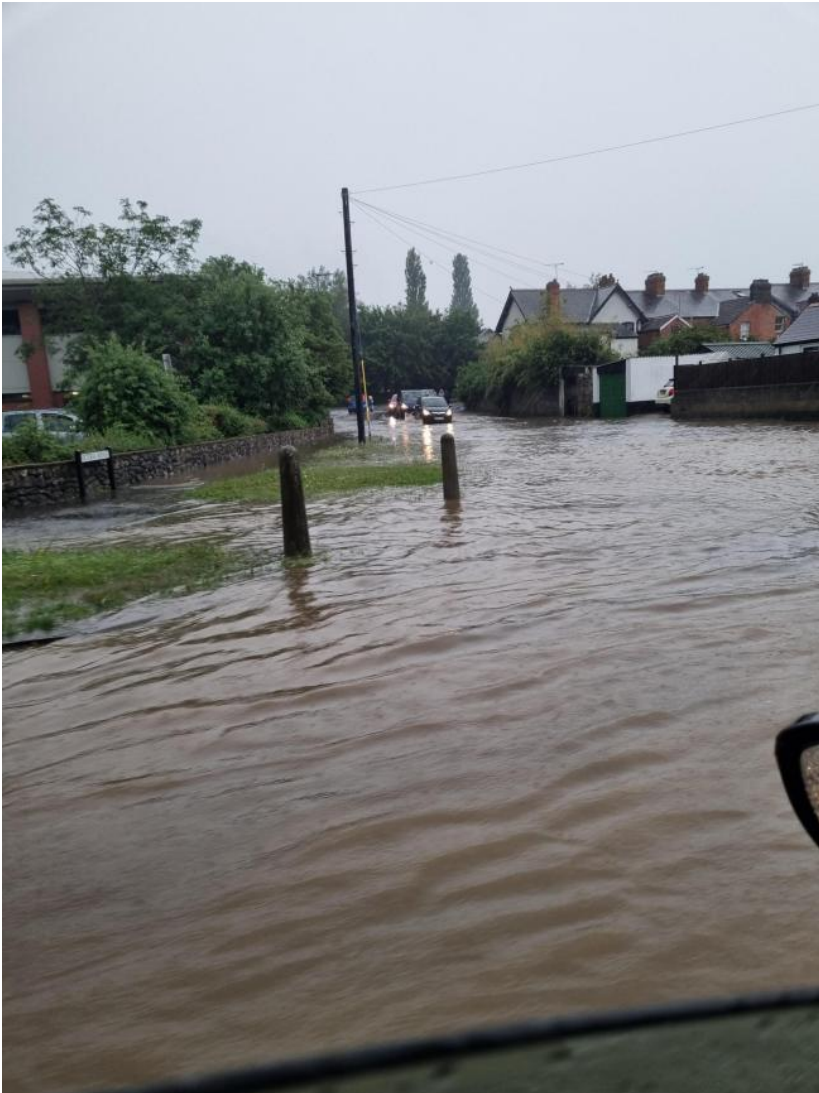
Figure 19: Outside B&Q, Furnham Road, Chard.

Furnham Road, Furnham Road Industrial Estate, and parts of Glynswood were badly flooded. Furnham road was particularly badly flooded outside B&Q. Furnham road suffered particularly deep flooding, believed to be over a metre in depth.

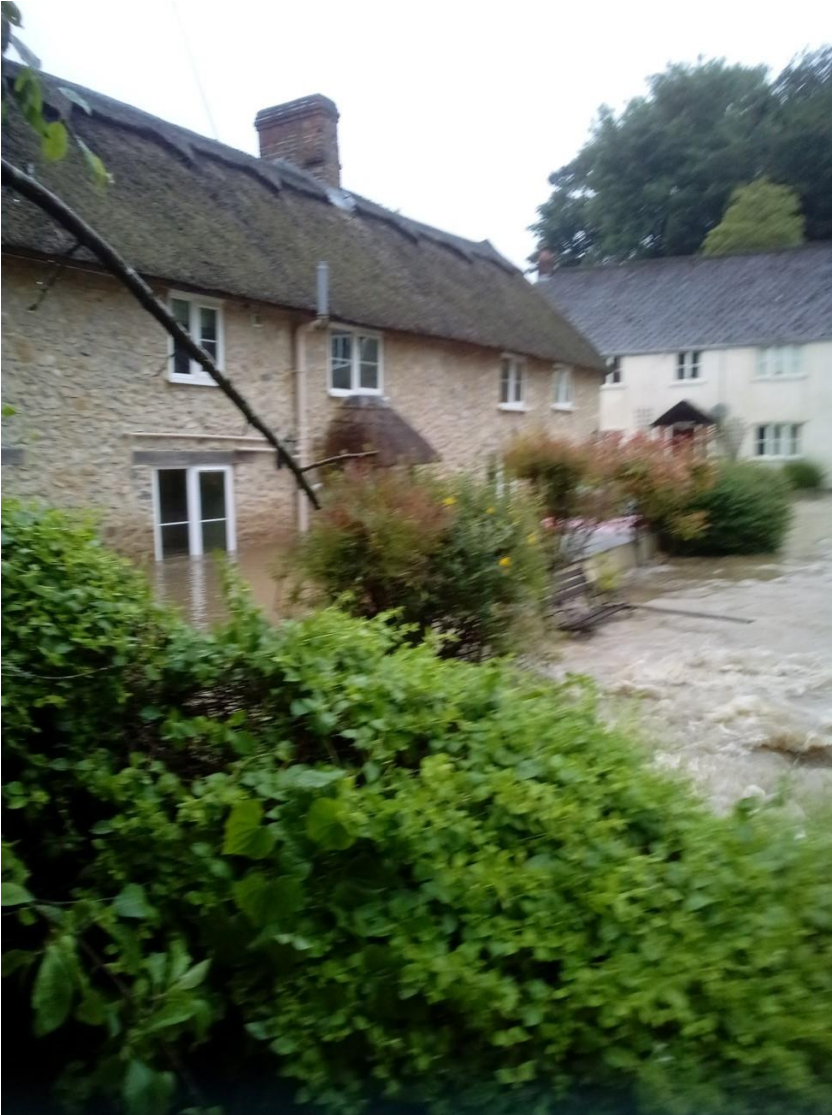
Figure 22: The front of a house on Court Mill Lane – note that the water is up over the window ledges. Photo supplied by Parish Clerk.

Flooding in Wadeford rose extremely high in places, and water ran down the sloping streets to the bottom of the village with considerable force and speed.

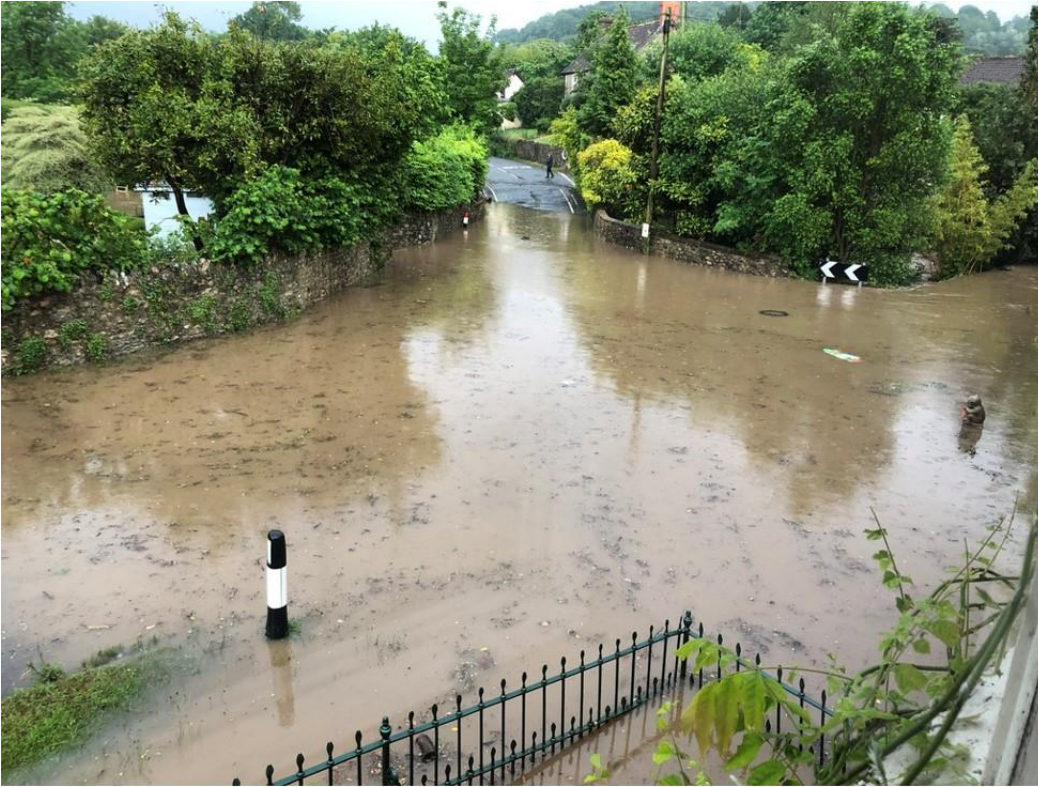
Figure 23: Main road Wadeford Bends taken from bedroom of a house at Chapel Triangle. Photo supplied by Parish Clerk.

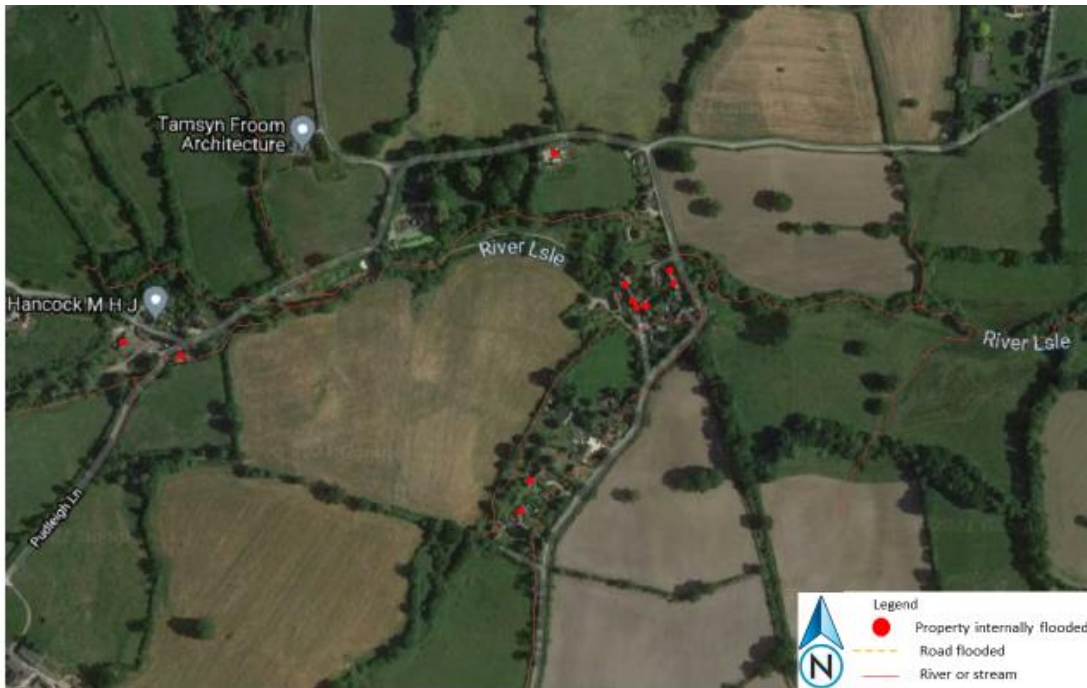
Figure 26: Flooded properties in Nimmer.

Again, here the main flooding mechanism, as reported by the Parish Council, was the overland flow of surface water from nearby fields to a topographical lowpoint. Residents near the river explicitly stated that they were flooded from overland flow, not from the river rising. Blocked drains and blocking of a culvert installed in 2009 were implicated as contributing to the problem.

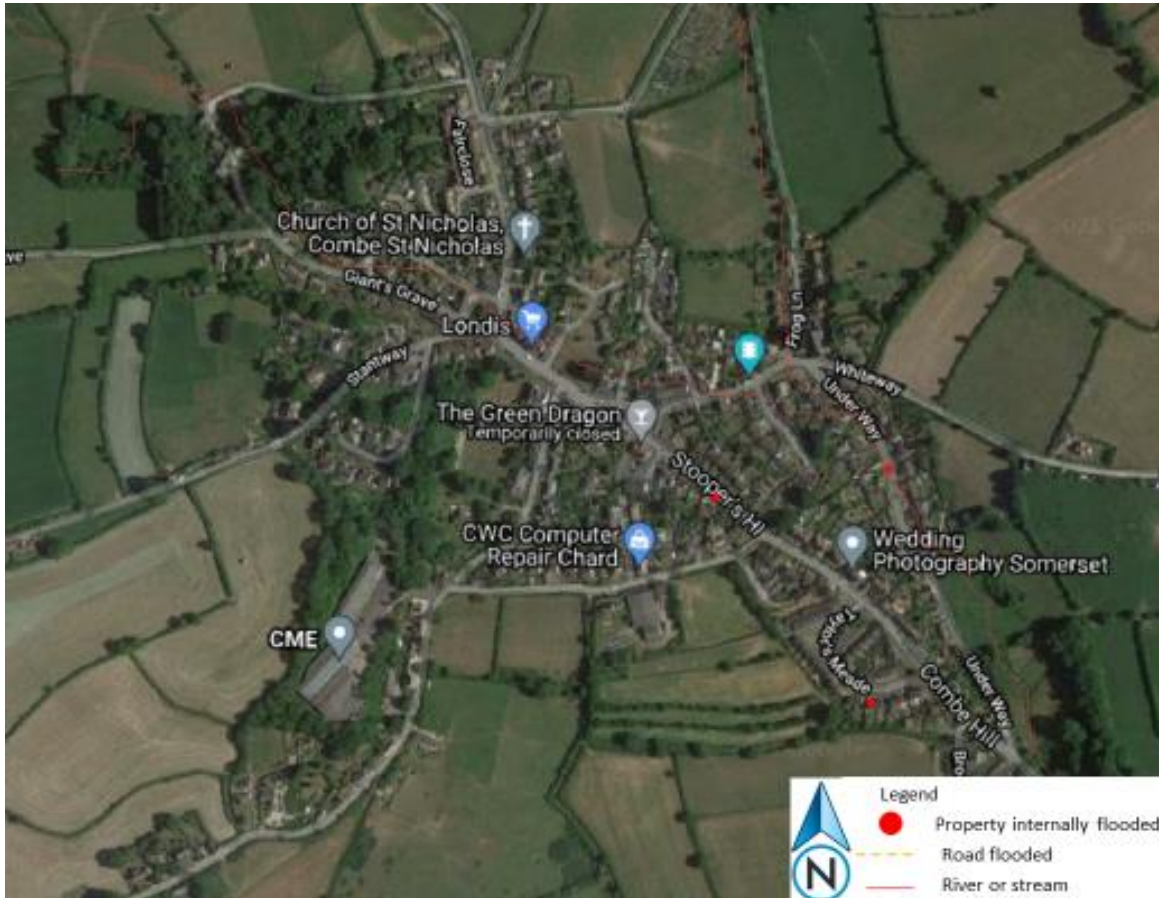
Figure 27: Flooded properties in Combe St Nicholas

The main mechanism of flooding here, according to Parish Council reports, was surface water running downhill off of nearby fields, and down Wadeford Hill / Combe Hill. The village is at a topographical lowpoint. They also reported that the watercourse in the centre of the village rose in level, and that some properties were affected by both flooding mechanisms.

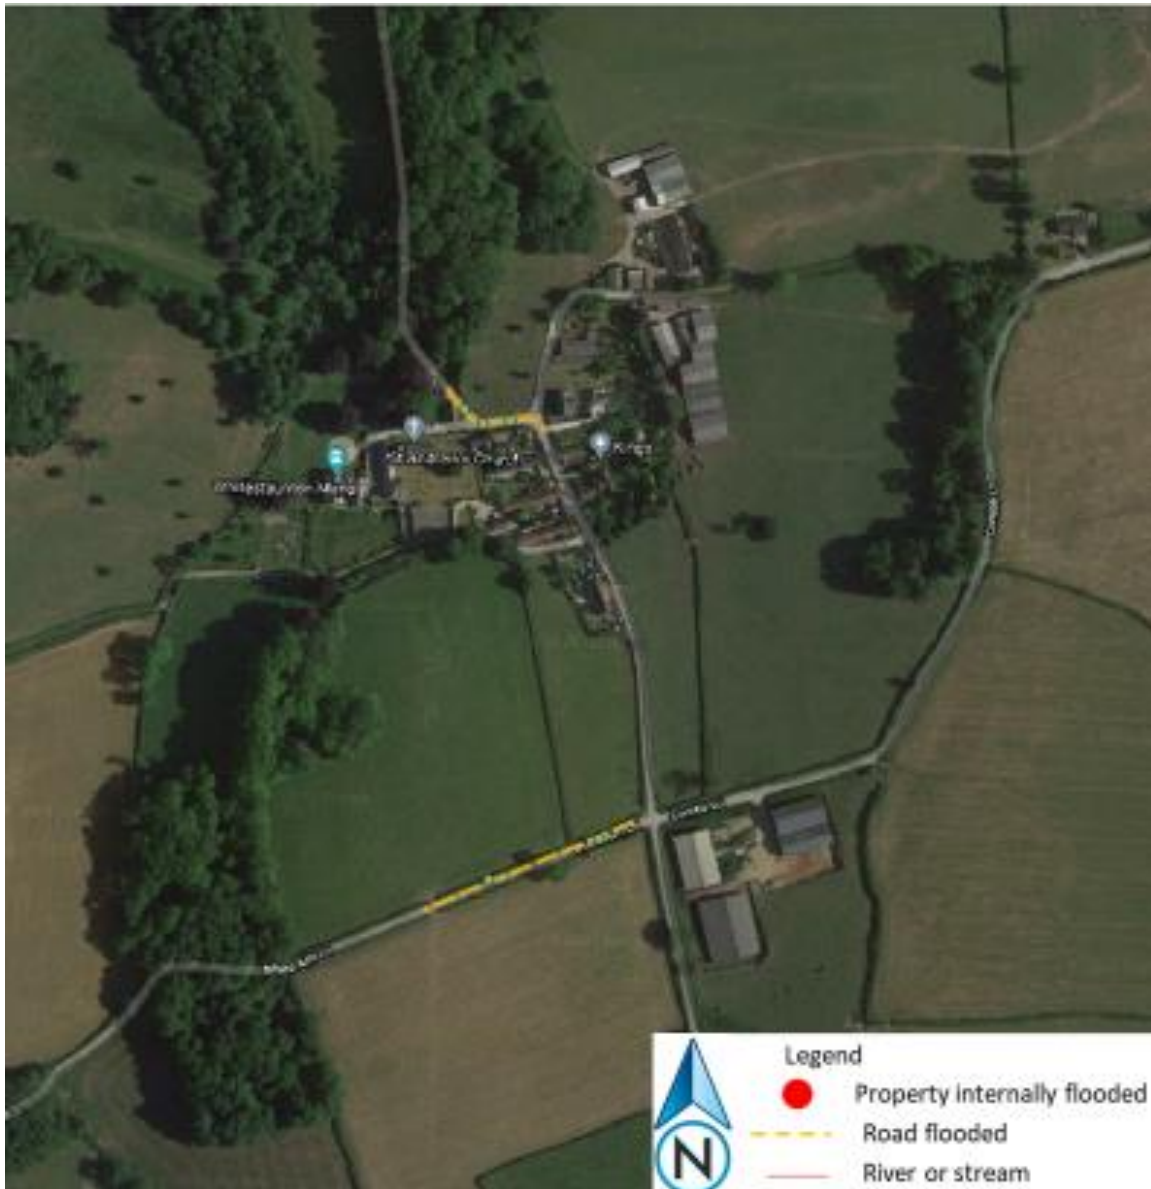
Figure 32: Flooded areas and damaged roads in Whitestaunton.

Note that the report for flooding and damage outside the settlement only named 'White Ash Lane'. The area shown is the steepest section, and therefore thought most likely to have sustained damage

There have been no reports thus far of houses flooding in **Whitestaunton**, but there have been reports of extensive road damage. This has apparently resulted from the force of the overland pluvial flow down White Ash Lane and Mill Lane.

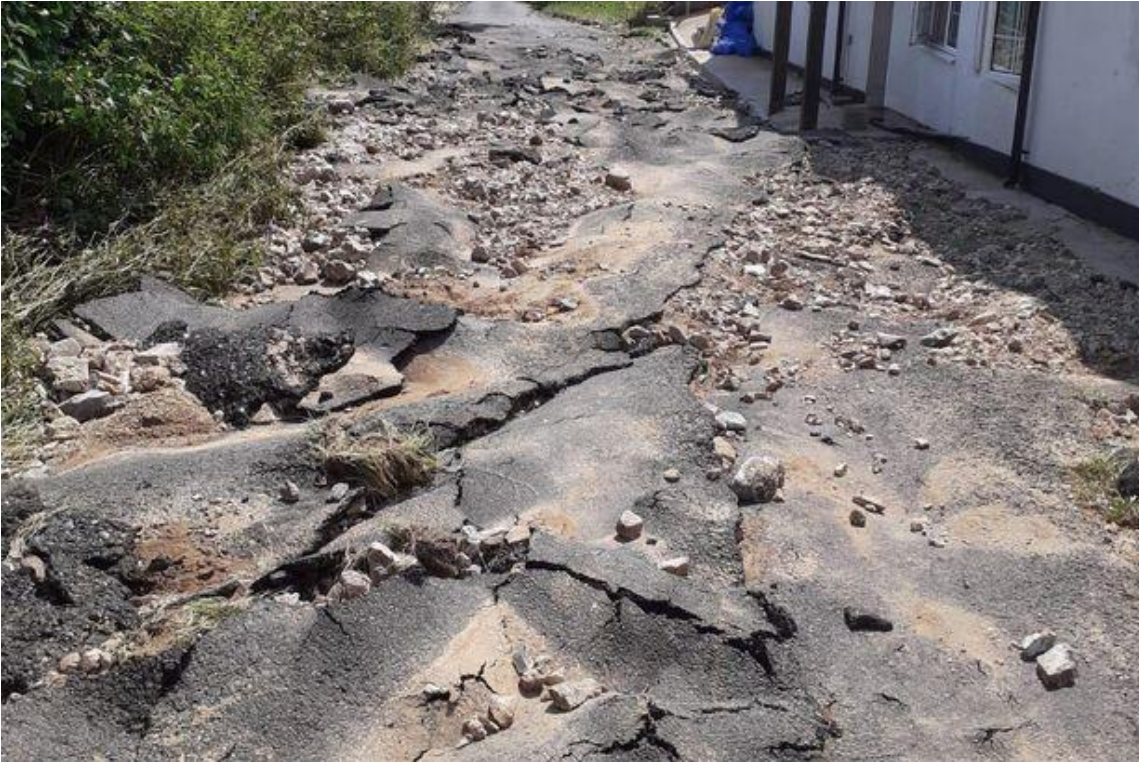
Figure 34: Damage to Scampton lane. From
[Chard flooding aftermath leaves roads completely destroyed - Somerset Live.](#)

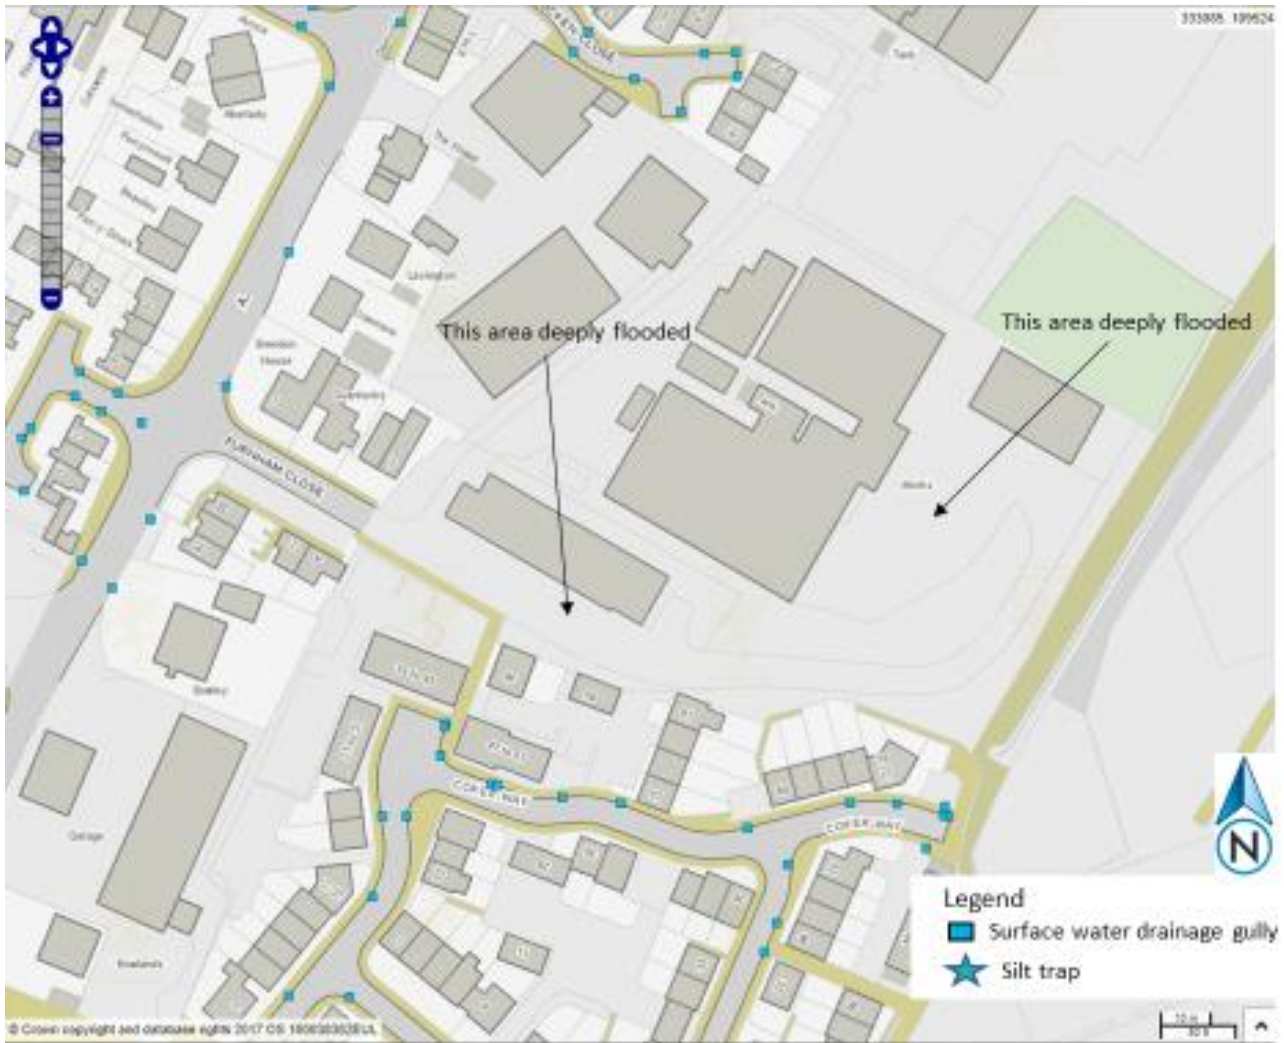
Figure 38: Surface water drains in Furnham Road Industrial Estate.

The absence of any apparent gullies around the Furnham Road industrial estate needs to be looked at and the location of private gullies recorded, along with their ownership.
